Manhole Inspection Summary

Manhole # S08CC2012MH

Insp Date: **6/30/06 10:50 AM**

Location Address: **7062 GLENGYLE AVE**

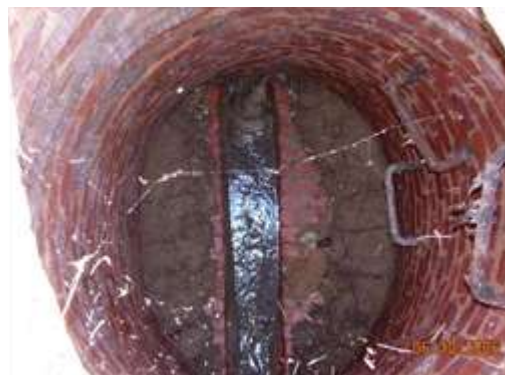
Top View

Adjustment and Barrel infiltration. Evidence of surcharge - Bench debris. Channel debris. Corroded steps.

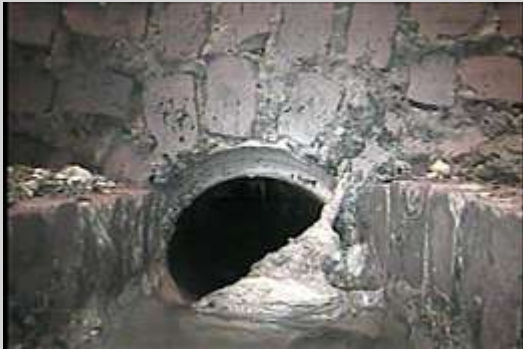
8 in. Circular Gravity Sewer Pipe Out @ 12 O'Clock

Pipe Material: **Clay** ☐ Pipe Lined

Invert Depth: **8.55** (ft.) Flow Characteristics: **Slow**

Deposits: ☐ None ☒ **Mud** ☐ Sludge ☒ **Debris** ☐ Grease

Silt Depth: **1** (in.) Deposits Extent: **Medium**

Infiltration: **Evidence** Pipe Seal Cond: **Unknown**

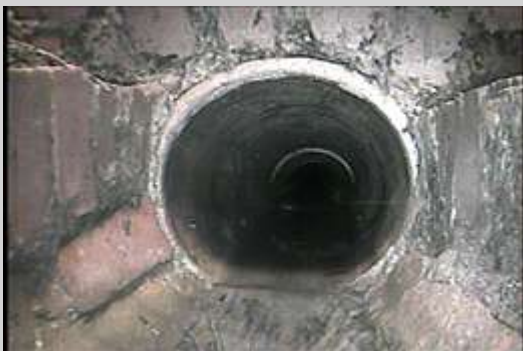
8 in. Circular Gravity Sewer Pipe In @ 6 O'Clock

Pipe Material: **Clay** ☐ Pipe Lined

Invert Depth: **8.13** (ft.) Flow Characteristics: **Slow**

Infiltration: **Evidence** Pipe Seal Cond: **Unknown**
